# HONDA

## INSTALLATION INSTRUCTIONS

Accessory  
**BED EXTENDER**  
P/N 08L74-HL3-A41

Application  
**SXS700M4/M2**

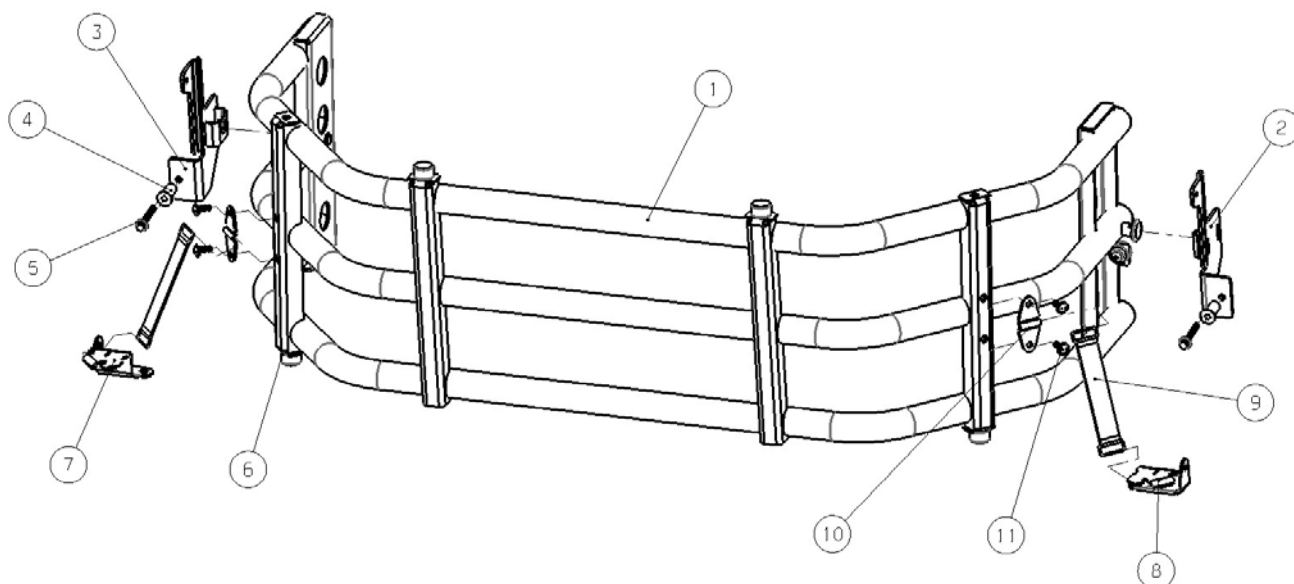
### PARTS LIST

| No. | Description | Qty |
| (1) | Bed extender | 1 |
| (2) | Right bracket, bed extender | 1 |
| (3) | Left bracket, bed extender | 1 |
| (4) | Collar | 2 |
| (5) | 6 mm flange bolt | 2 |
| (6) | Rubber stop | 6 |
| (7) | Left tailgate bracket | 1 |
| (8) | Right tailgate bracket | 1 |
| (9) | Strap | 2 |
| (10) | Strap bracket | 2 |
| (11) | 6 x 12 mm socket bolt | 4 |

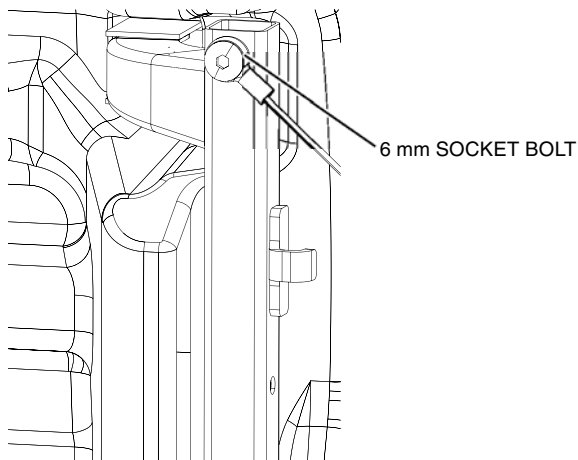
1. Remove the upper 6 mm socket bolt from the rear frame and save it for reuse.

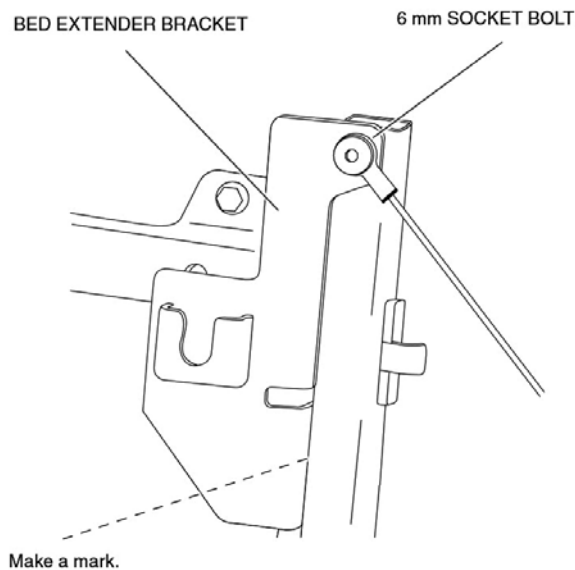
2. **'14 Only:** Refer to the Service Manual for the vehicle, remove the bed side cover (2P only), rear door (4P only) and inside cover (4P only).
3. **'14 Only:** Place the bed extender bracket into the position shown and temporarily install the 6 mm socket bolt. Using the bracket as a template, mark the hole location with a marker.

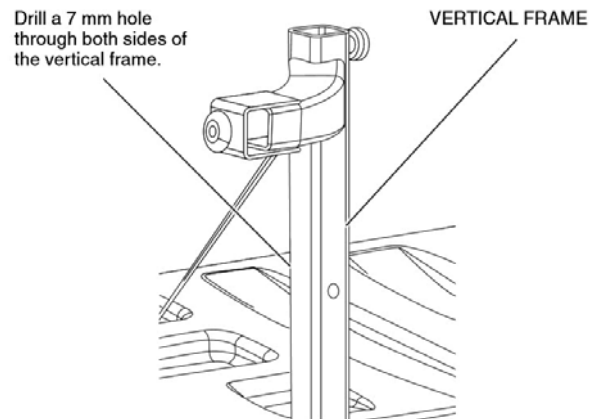
4. **'14 Only:** Remove the 6 mm socket bolt and bed extender bracket. Drill a 7 mm hole in the vertical frame at the marked point.
  - **This hole will go through both sides of the frame.**

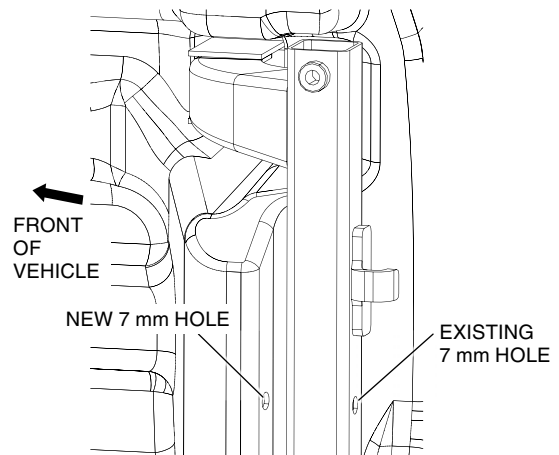
5. **'14 Only:** Reinstall removed parts per the Service Manual.
6. Using the two existing 7 mm through holes as a guide, drill a 7 mm hole in the bed plastic.

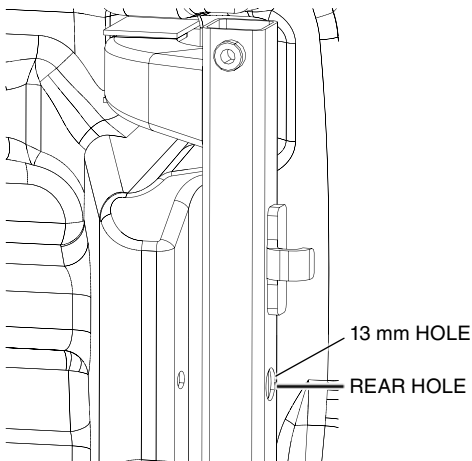
7. Using the existing 7 mm through hole as a pilot hole, enlarge the rear frame hole with a 13 mm drill bit.  
**NOTICE: Drill the rear hole carefully to avoid damaging the front frame 7 mm hole.**

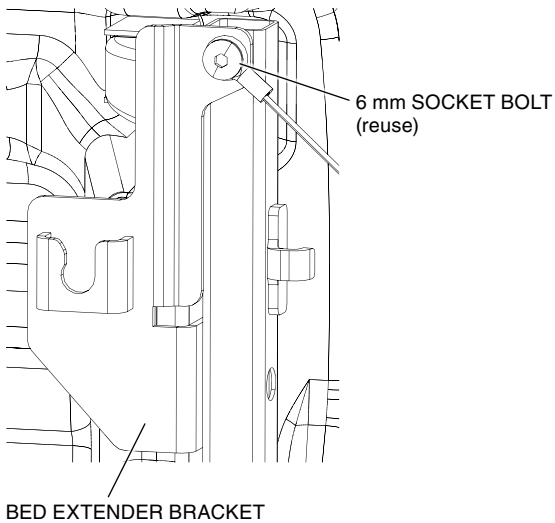
8. Place the bed extender bracket into the position shown and loosely install the 6 mm socket bolt.

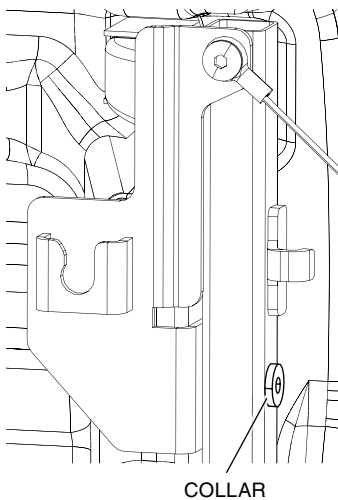
9. Insert the collar into the 13 mm hole.

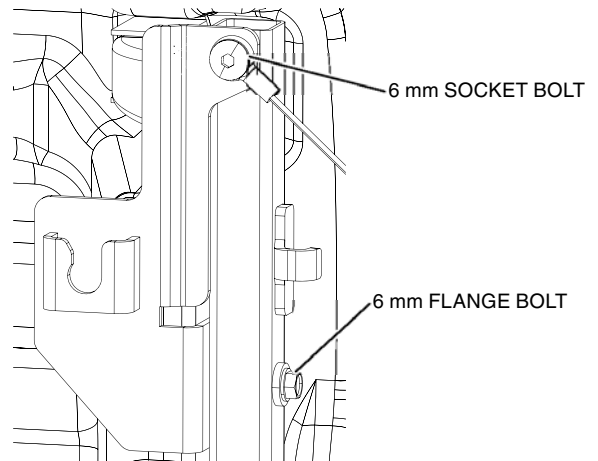
10. Install a 6 mm flange bolt through the collar and tighten it into the weld nut on the bed extender bracket. Tighten the 6 mm flange bolt and 6 mm socket bolt to the specification in the Torque Chart.

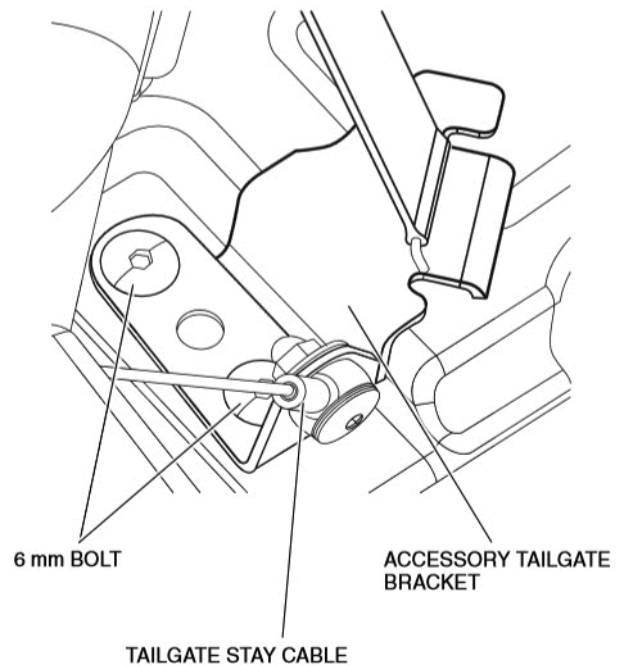
11. Remove the tailgate stay cable and replace the bracket with the accessory tailgate bracket. Reinstall the tailgate stay cable and tighten the 6 mm bolts to the specification in the Torque Chart.

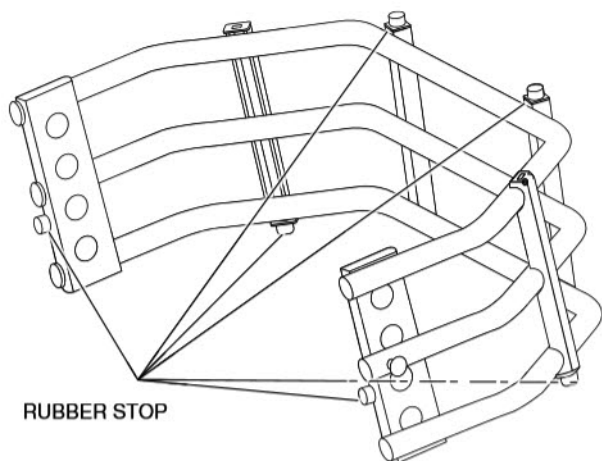
13. Install the rubber stops into the bed extender holes at the areas shown below.

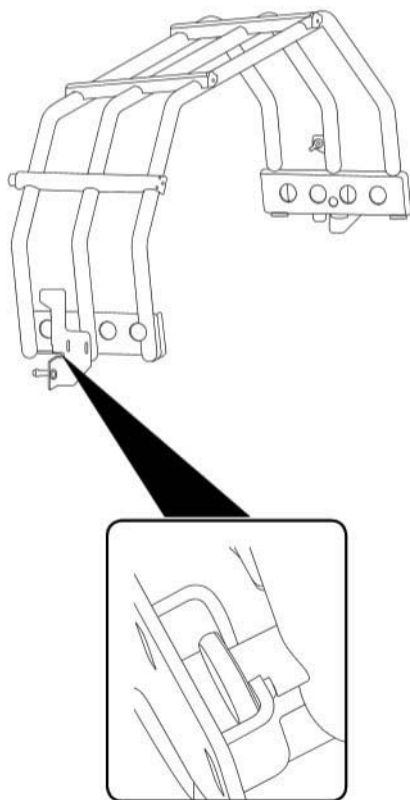
14. Holding the bed extender assembly vertically, gently lower it into the bed extender brackets.

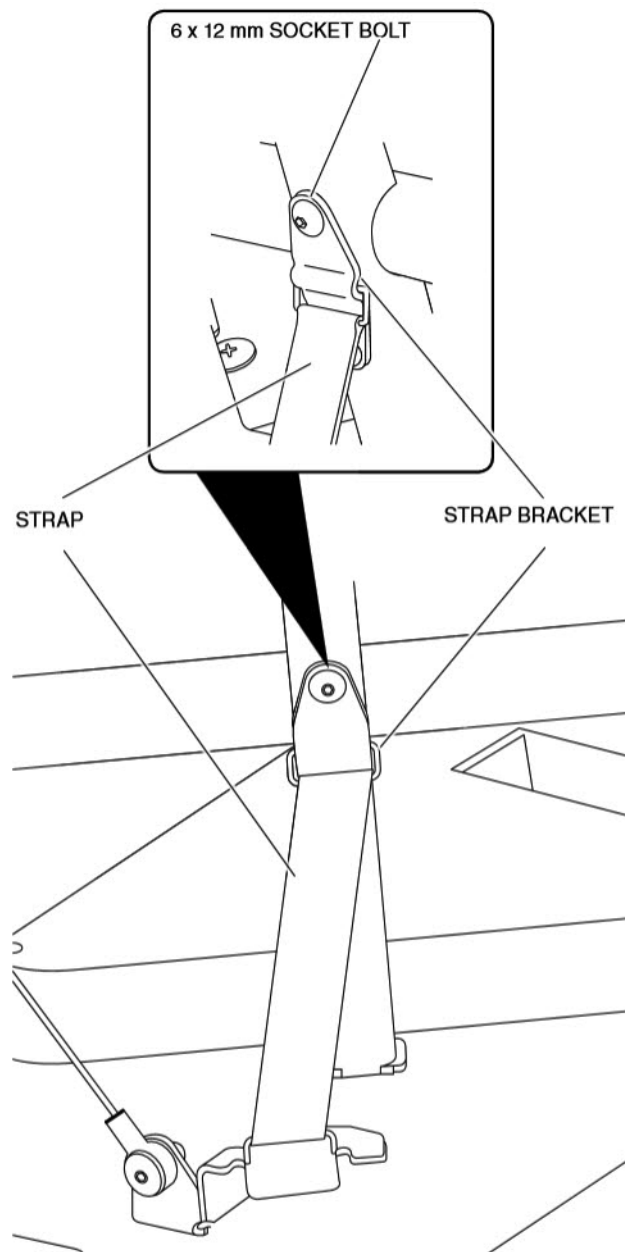
15. Install the strap and the strap bracket to the bed extender using the 6 x 12 mm socket bolts.
